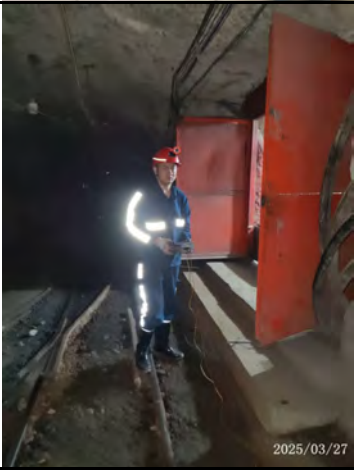
| 24 | GX-B1350/21-2-25011 | 2025. 4. 9 | 所检项目合格。 | <br>2025/03/27 |

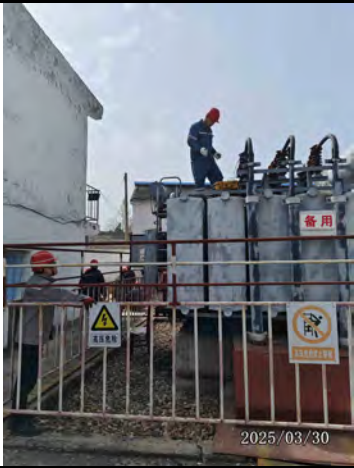
| 26 | GX-B1313/21-2-25084~25085 | 2025. 4. 9 | 本次共检电力变压器2台，2台所检项目合格。<br>。 | |

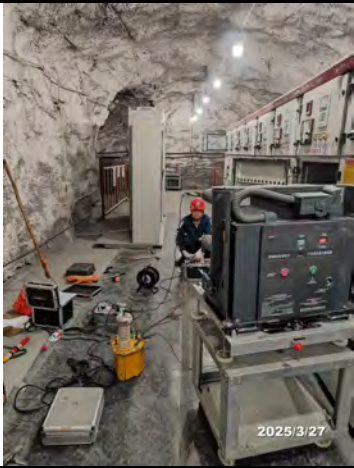
| 28 | GX-B1451/20-2-25216~25228 | 2025. 4. 8 | 本次共检高压开关柜13台，13台高压开关柜所检项目合格。 | |

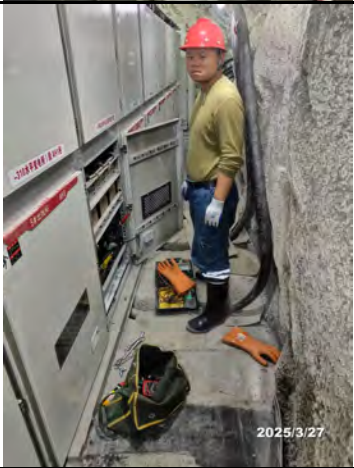
| 30 | GX-B1322/21-2-25124~25131 | 2025. 4. 8 | 本次共检验电力电缆8条，8条所检项目合格。 | |

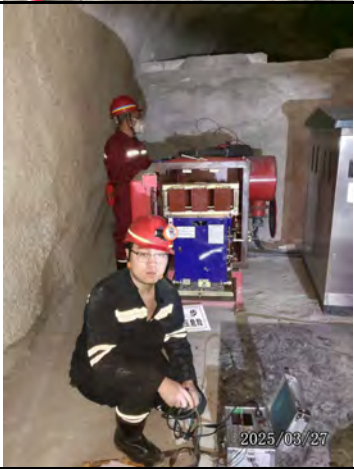
| 32 | GX-B1451/20-2-25135~25146 | 2025. 4. 10 | 所检项目合格。 | |

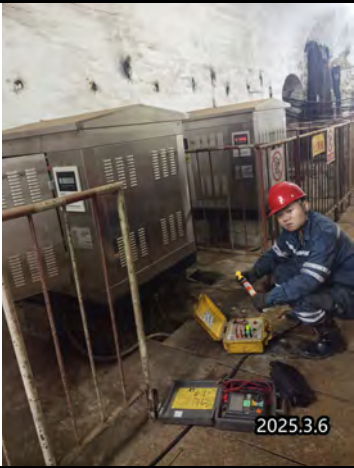
| 34 | GX-B1313/21-2-25138~25149 | 2025. 4. 10 | 所检项目合格。 | | |

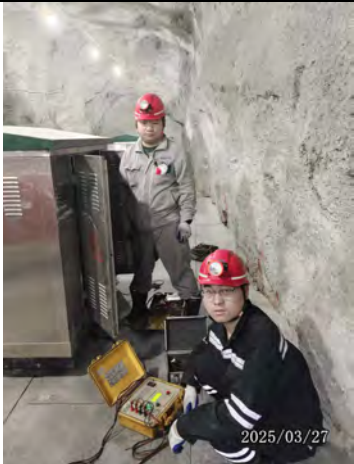
| 35 | GX-B1313/21-2-25069~25079 | 2025. 4. 10 | 所检项目合格。 | |

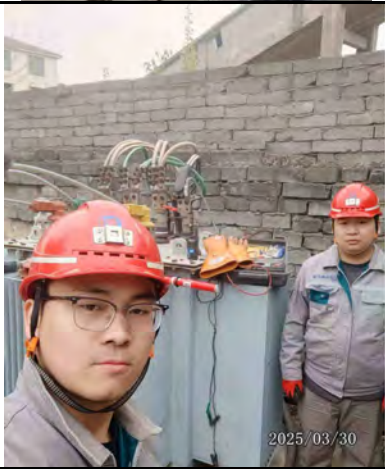
| 36 | GX-B1313/21-2-25080~25081 | 2025. 4. 10 | 所检项目合格。 | |

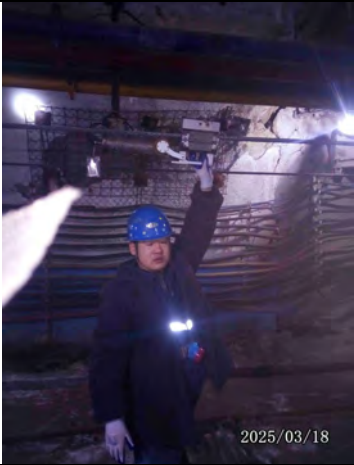
| 37 | GX-B1598/24-2-25049 | 2025. 4. 10 | 实测钢丝绳有效截面积<br>损失百分比最大为<br>0.97%，<br>小于5%为正常。 | | |

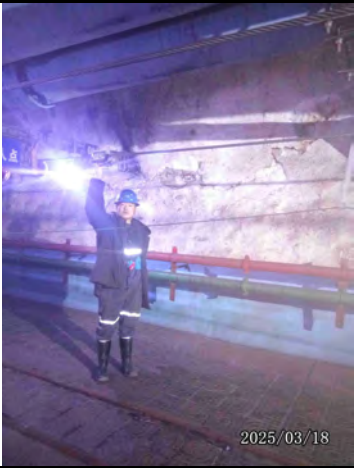
| 38 | GX-B1598/24-2-25050 | 2025. 4. 10 | 实测钢丝绳有效截面积<br>损失百分比最大为<br>2.47%，<br>小于5%为正常。 | | |

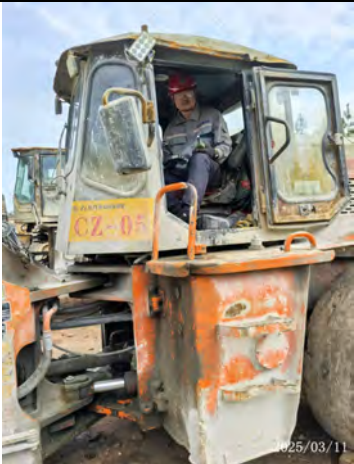
| 39 | GX-B1539/22-2-25004 | 2025. 4. 10 | 除坐姿司机室基本出入口高度小于1300mm外，其余所检项目合格。 | |

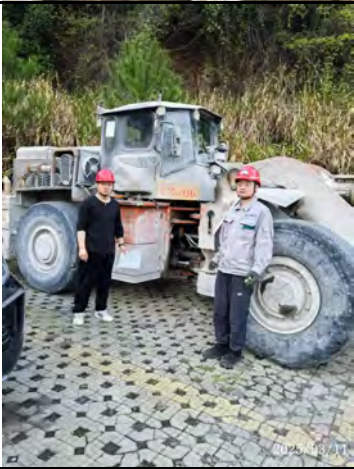
| 40 | GX-B1539/22-2-25005 | 2025. 4. 10 | 除坐姿司机室基本出入口高度小于1300mm外，其余所检项目合格。 | |

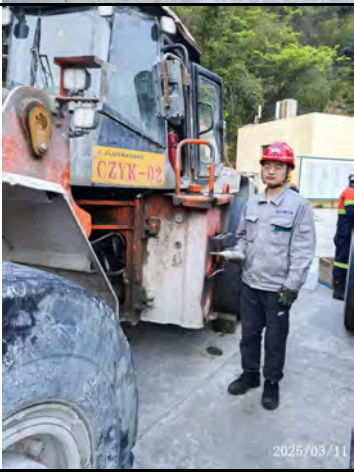
| 42 | GX-B1539/22-2-25007 | 2025. 4. 10 | 除坐姿司机室基本出入口高度小于1300mm外，其余所检项目合格。 | |

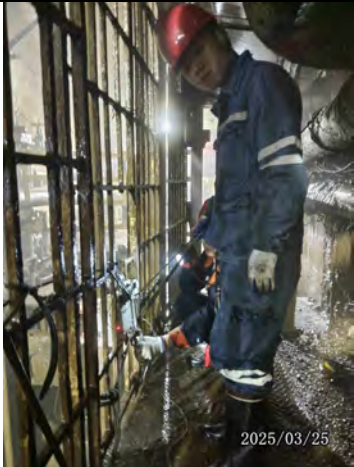
| 59 | GX-B1598/24-2-25071 | 2025/4/10 | 实测钢丝绳有效截面积<br>损失百分比最大为<br>4.94%，小于5%为正常。 | |

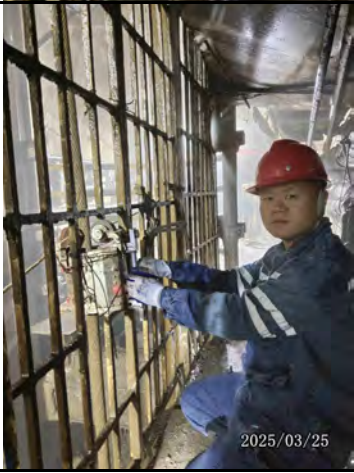
| 60 | GX-B1598/24-2-25072 | 2025/4/10 | 实测钢丝绳有效截面积<br>损失百分比最大为<br>4.97%，小于5%为正常。 | |

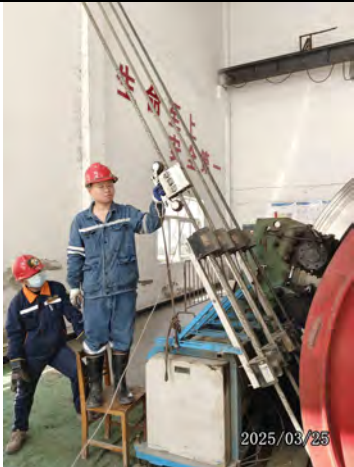
| 61 | GX-B1598/24-2-25073 | 2025/4/10 | 实测钢丝绳有效截面积<br>损失百分比最大为<br>1.38%，小于5%为正常。 | |

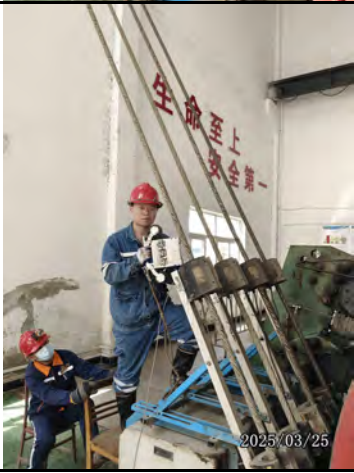
| 62 | GX-B1598/24-2-25074 | 2025/4/10 | 实测钢丝绳有效截面积<br>损失百分比最大为<br>1.29%，小于5%为正常。 | |

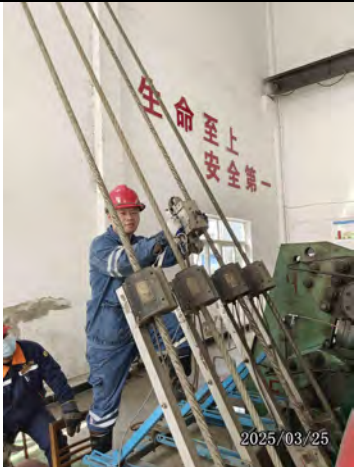
| 63 | GX-B1598/24-2-25075 | 2025/4/10 | 实测钢丝绳有效截面积<br>损失百分比最大为<br>1.17%，小于5%为正常。 | |

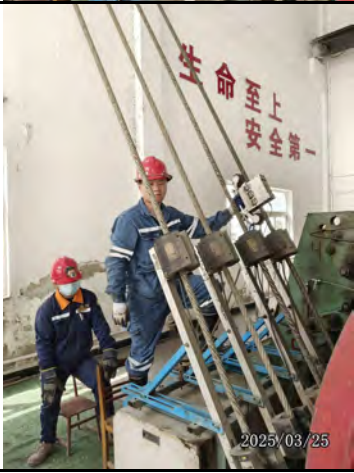
| 64 | GX-B1598/24-2-25076 | 2025/4/10 | 实测钢丝绳有效截面积<br>损失百分比最大为<br>1.18%，小于5%为正常。 | |

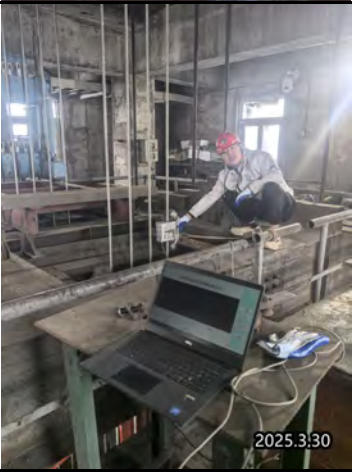
| 88 | GX-B1598/24-2-25065 | 2025/4/11 | 实测钢丝绳有效截面积<br>损失百分比最大为<br>0.23%，小于5%为正常。 | |

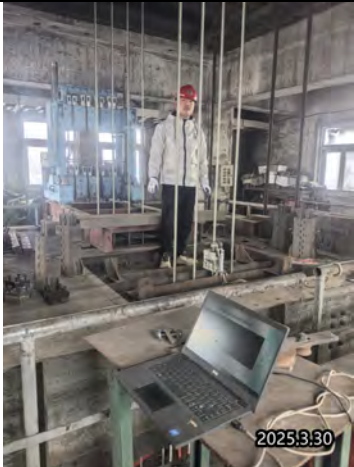
| 89 | GX-B1598/24-2-25066 | 2025/4/11 | 实测钢丝绳有效截面积<br>损失百分比最大为<br>0.24%，小于5%为正常。 | |

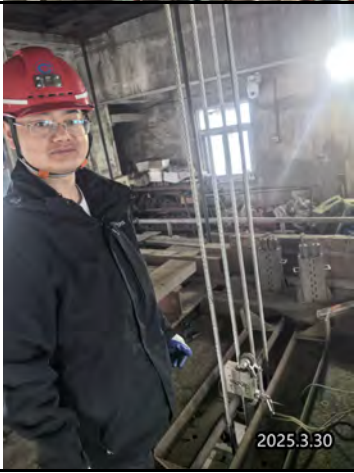
| 90 | GX-B1598/24-2-25067 | 2025/4/11 | 实测钢丝绳有效截面积<br>损失百分比最大为<br>0.75%，小于5%为正常。 | |

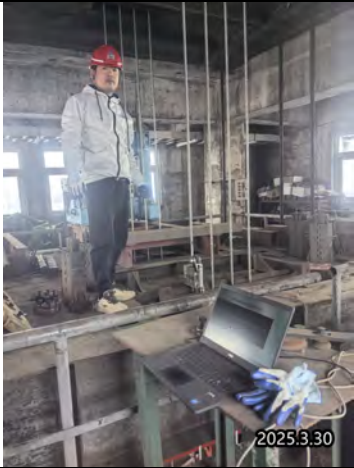
| 91 | GX-B1598/24-2-25068 | 2025/4/11 | 实测钢丝绳有效截面积<br>损失百分比最大为<br>0.87%，小于5%为正常。 | |

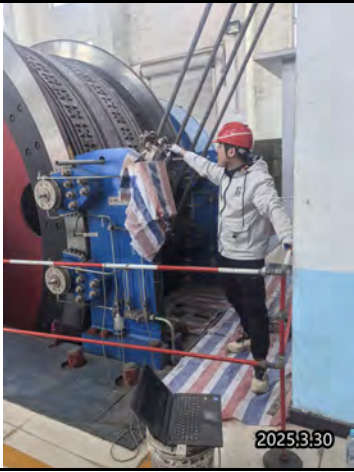
| 92 | GX-B1598/24-2-25061 | 2025/4/11 | 实测钢丝绳有效截面积<br>损失百分比最大为<br>2.72%，小于5%为正常。 | |

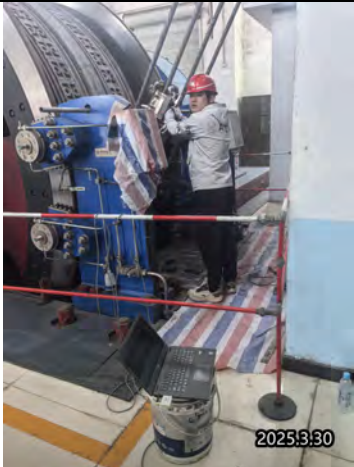
| 93 | GX-B1598/24-2-25062 | 2025/4/11 | 实测钢丝绳有效截面积<br>损失百分比最大为<br>2.06%，小于5%为正常。 | |

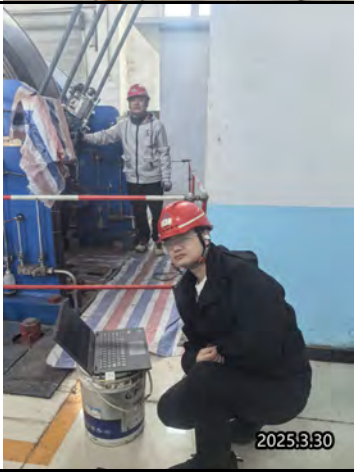
| 94 | GX-B1598/24-2-25063 | 2025/4/11 | 实测钢丝绳有效截面积<br>损失百分比最大为<br>3.06%，小于5%为正常。 | |

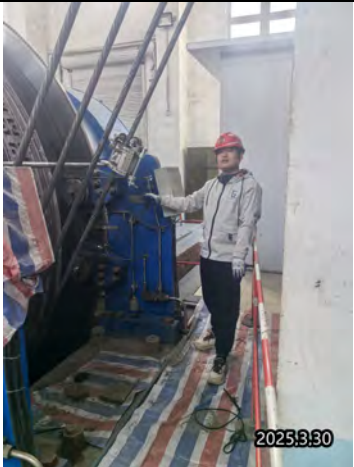
| 95 | GX-B1598/24-2-25064 | 2025/4/11 | 实测钢丝绳有效截面积<br>损失百分比最大为<br>2.02%，小于5%为正常。 | |
