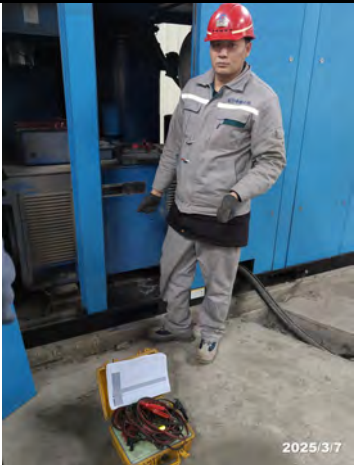
| 序号 | 报告编号 | 发布日期 | 结论 | 影像资料 |
|---|---|---|---|---|
| 21 | GX-B1324/21-2-25006~25008 | 2025. 4. 8 | 所检项目合格。 | |

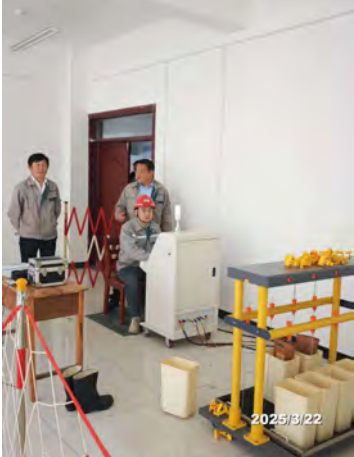
| 序号 | 报告编号 | 发布日期 | 结论 | 影像资料 |
|---|---|---|---|---|
| 22 | GX-B1328/20-2-25037 | 2025. 4. 8 | 本次共检绝缘手套18只，18只绝缘手套合格。 | |

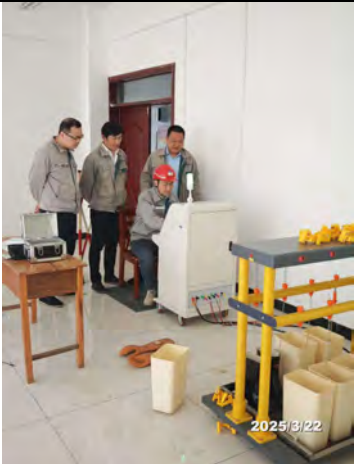
| 23 | GX-B1328/20-2-25038 | 2025. 4. 8 | 本次共检绝缘靴<br>20只，20只绝缘靴合格。 | <br>2025/3/22 |

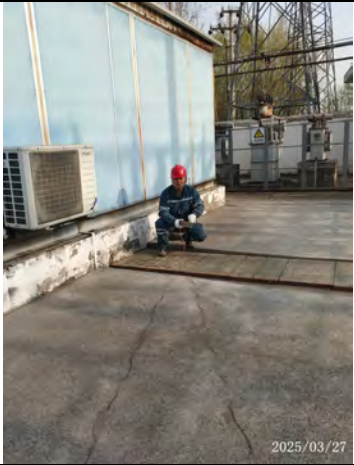
| 25 | GX-B1350/21-2-25012 | 2025. 4. 9 | 本次共检验接地装置5处，5处所检项目合格。<br>。 | |

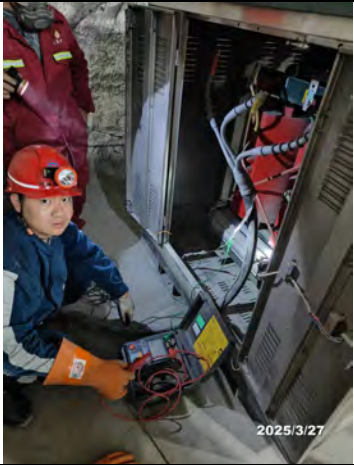
| 27 | GX-B1313/21-2-25089~25091 | 2025. 4. 9 | 本次共检电力变压器3台，3台所检项目合格。<br>。 | |

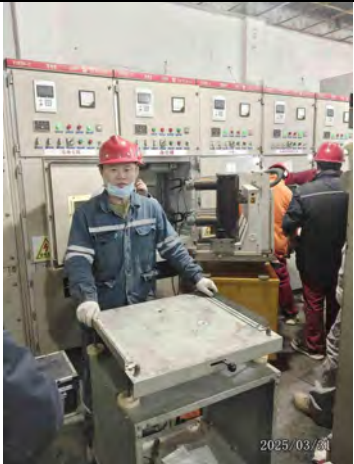
| 29 | GX-B1451/20-2-25229~25243 | 2025. 4. 8 | 本次共检高压开关柜15台，15台高压开关柜所检项目合格。 | |

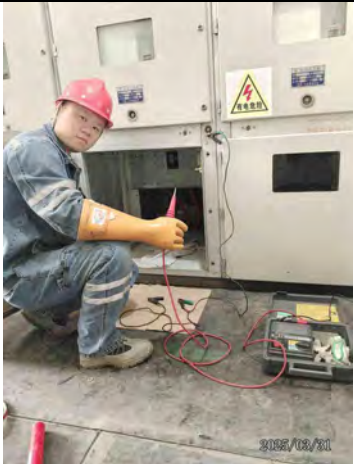
| 31 | GX-B1322/21-2-25132~25137 | 2025. 4. 8 | 本次共检验电力电缆6条，6条所检项目合格。 | |

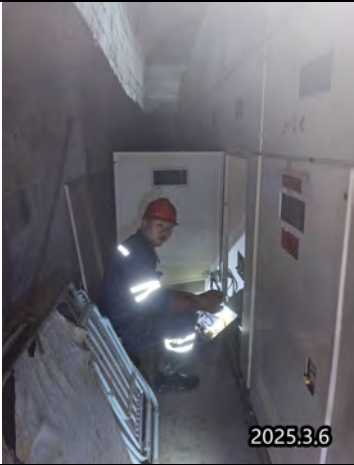
| 33 | GX-B1322/21-2-25091~25119 | 2025. 4. 10 | 所检项目合格。 | | |

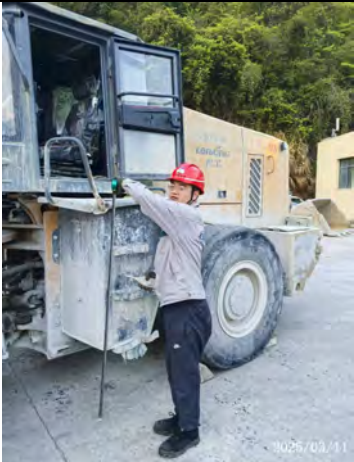
| 41 | GX-B1539/22-2-25006 | 2025. 4. 10 | 除坐姿司机室基本出入口高度小于1300mm外，其余所检项目合格。 | |

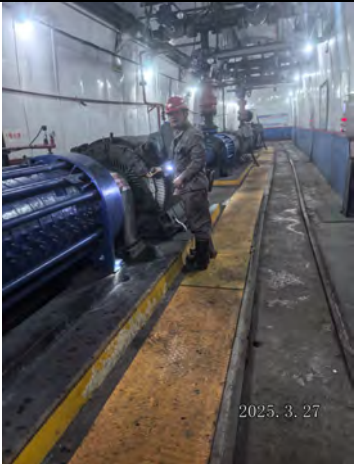
| 43 | GX-B1499/23-2-25010 | 2025. 4. 10 | 所检项目合格。 | | |

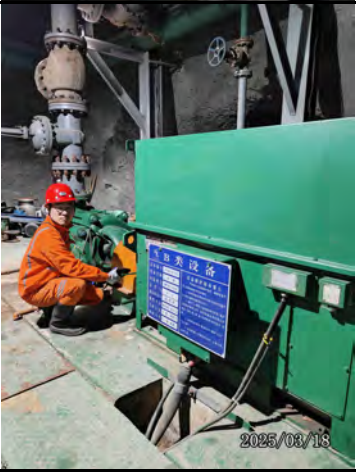
| 48 | GX-B1500/21-2-25036 | 2025. 4. 10 | 综合判定：合格。 | |

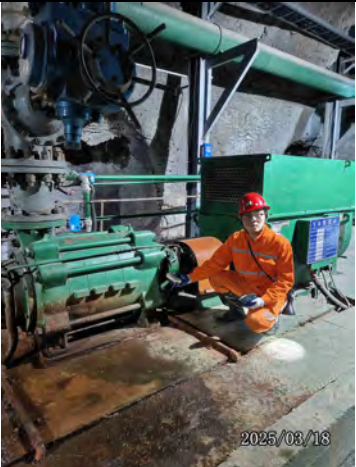
| 49 | GX-B1500/21-2-25037 | 2025. 4. 10 | 综合判定：合格。 | |

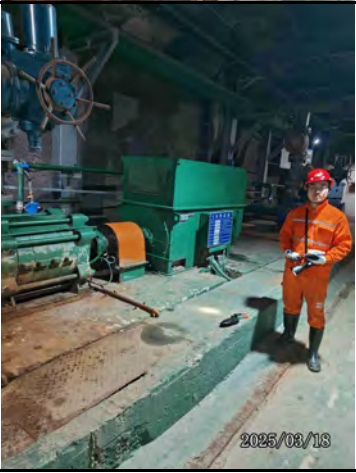
| 50 | GX-B1500/21-2-25038 | 2025. 4. 10 | 综合判定：合格。 | |

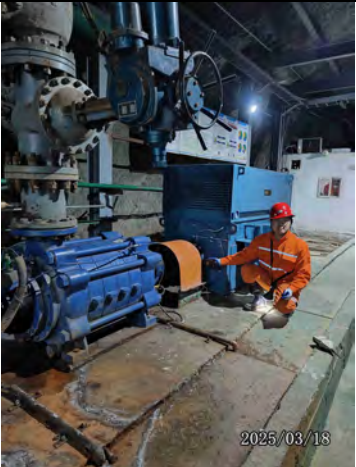
| 51 | GX-B1500/21-2-25039 | 2025. 4. 10 | 综合判定：合格。 | |

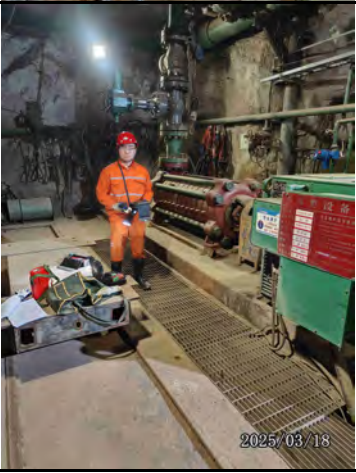
| 52 | GX-B1500/21-2-25040 | 2025. 4. 10 | 综合判定：合格。 | |

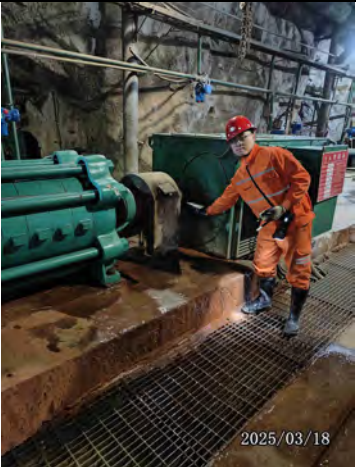
| 53 | GX-B1500/21-2-25041 | 2025. 4. 10 | 综合判定：合格。 | |

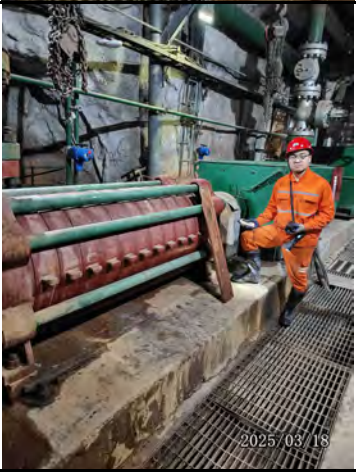
| 54 | GX-B1500/21-2-25042 | 2025. 4. 10 | 综合判定：合格。 | |

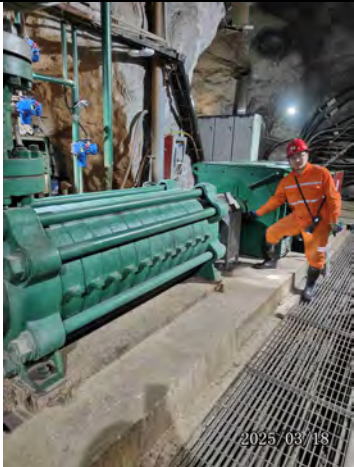
| 55 | GX-B1500/21-2-25043 | 2025. 4. 10 | 综合判定：合格。 | |

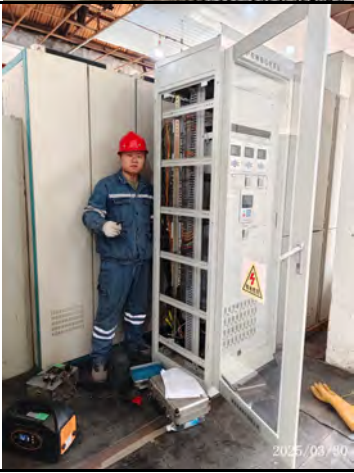
| 56 | GX-B1451/20-2-25244~25252 | 2025. 4. 9 | 本次共检继电保护装置9台，9台继电保护装置所检项目合格。 | |

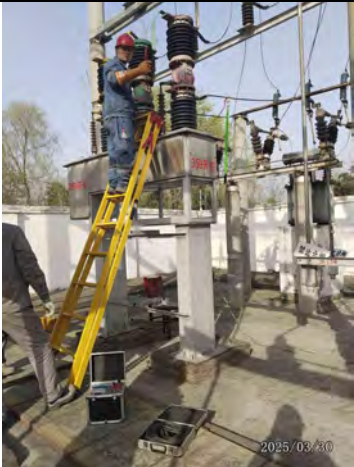
| 57 | GX-B1319/21-2-25006~25009 | 2025. 4. 9 | 本次共检高压交流断路器4台，4台高压交流断路器所检项目合格。 | |

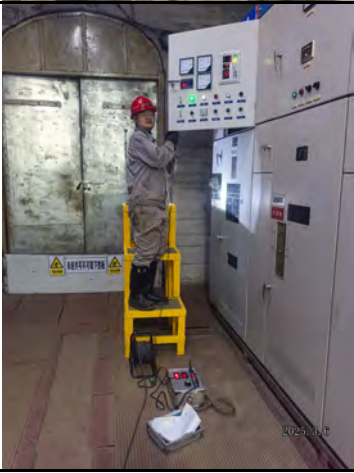
| 58 | GX-B1451/20-2-25156~25179 | 2025. 4. 9 | 本次共检高压开关柜24台，24台所检项目合格。 | |

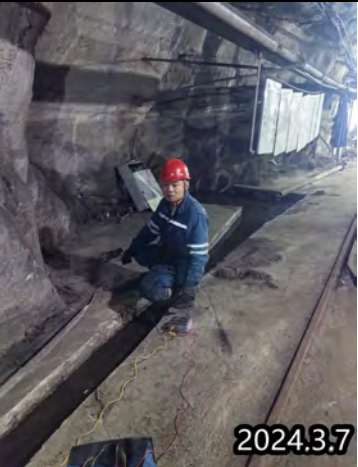
| 65 | GX-B1350/21-2-25013 | 2025/4/10 | 本次共检接地装置<br>10处，10处接地装置所<br>检项目合格。 | | | |

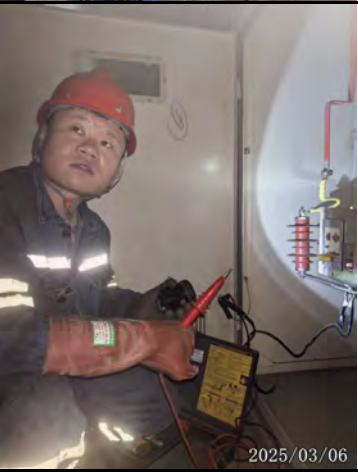
| 66 | GX-B1329/21-2-25116~25121 | 2025/4/10 | 本次共检氧化锌避雷器6<br>组，6组所检项目合格。 | | | |

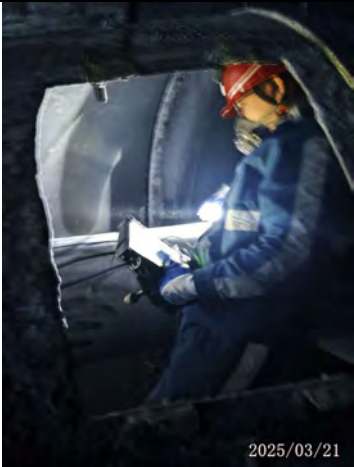
| 67 | GX-B1310/21-2-25051 | 2025/4/10 | 符合标准要求。 | |

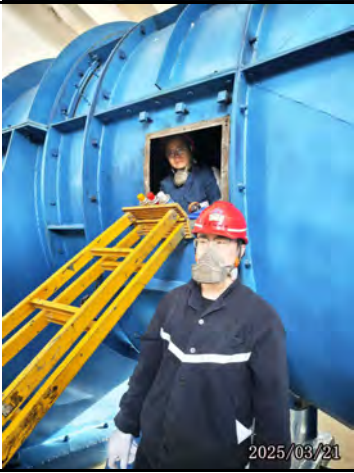
| 68 | GX-B1428/21-2-25051 | 2025/4/10 | 无缺陷痕迹显示。 | |

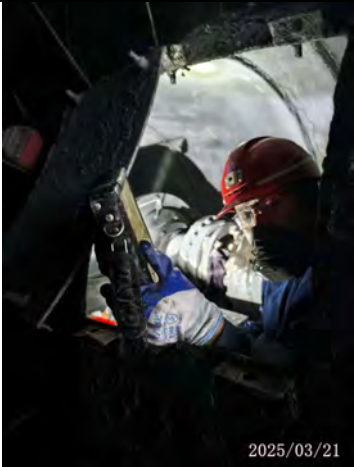
| 69 | GX-B1310/21-2-25052 | 2025/4/10 | 符合标准要求。 | |

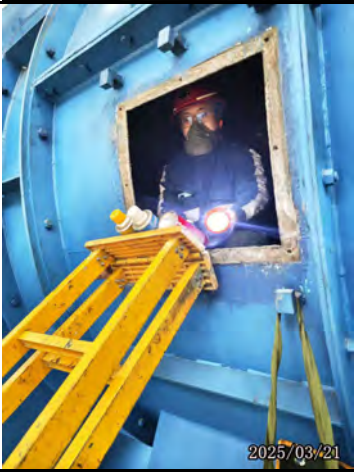
| 70 | GX-B1428/21-2-25052 | 2025/4/10 | 无缺陷迹痕显示。 | |

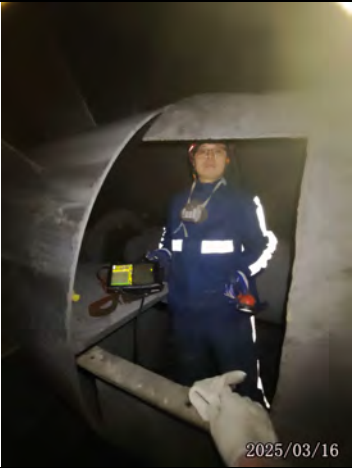
| 71 | GX-B1310/21-2-25046 | 2025/4/10 | 符合标准要求。 | | |

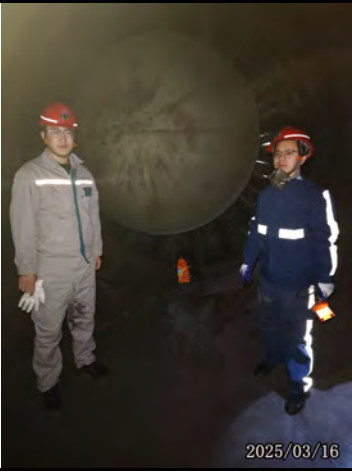
| 72 | GX-B1428/21-2-25046 | 2025/4/10 | 无缺陷迹痕显示。 | | |

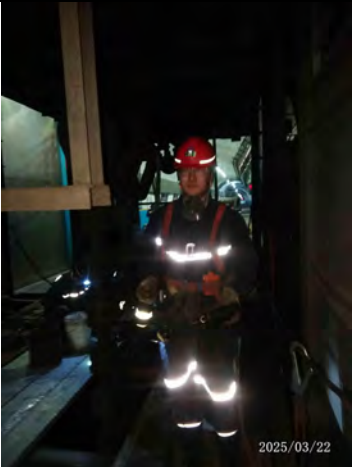
| 73 | GX-B1310/21-2-25053 | 2025/4/10 | 符合标准要求。 | | | |

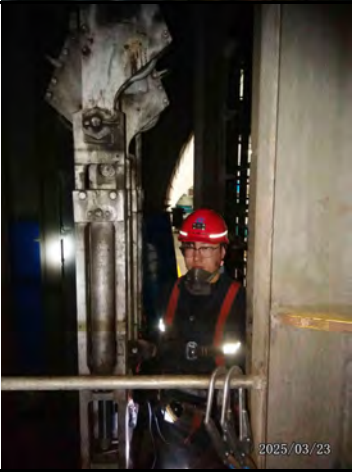
| 74 | GX-B1310/21-2-25054 | 2025/4/10 | 符合标准要求。 | | | |

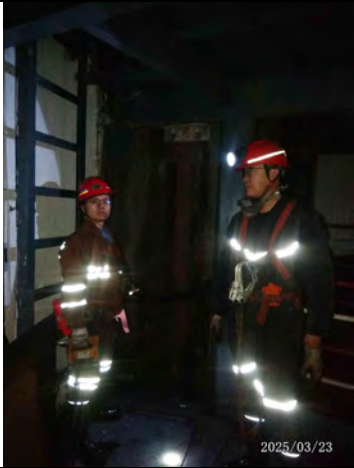
| 75 | GX-B1428/21-2-25054 | 2025/4/10 | 符合标准要求。 | A photograph showing two workers in red hard hats and reflective safety vests. They are in a dark environment, possibly a tunnel or a confined space, with their headlamps on. The date 2025/03/23 is visible in the bottom right corner of the image. |

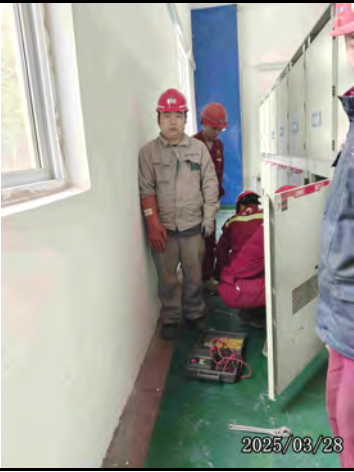
| 76 | GX-B1322/21-2-25120~25123 | 2025. 4. 11 | 所检项目合格。 | A photograph showing workers in a room with electrical equipment. One worker in a red hard hat and light-colored uniform is standing, while another is kneeling. There are electrical cabinets and equipment on the floor. The date 2025/03/23 is visible in the bottom right corner of the image. |

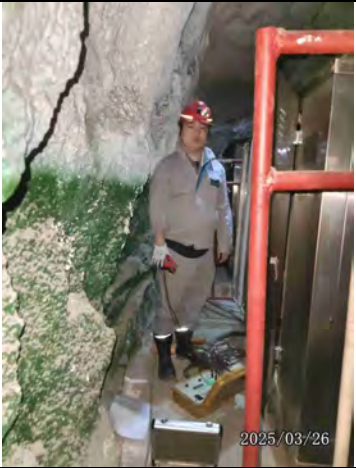
| 77 | GX-B1313/21-2-25067~25068 | 2025. 4. 11 | 所检项目合格。 | |

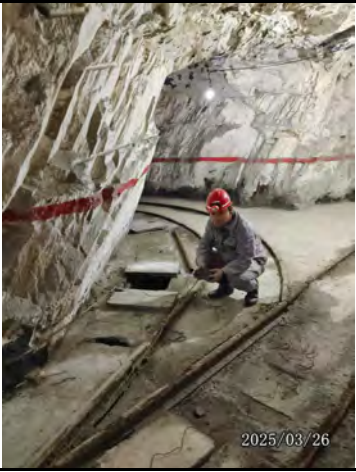
| 78 | GX-B1350/21-2-25010 | 2025. 4. 11 | 所检项目合格。 | |

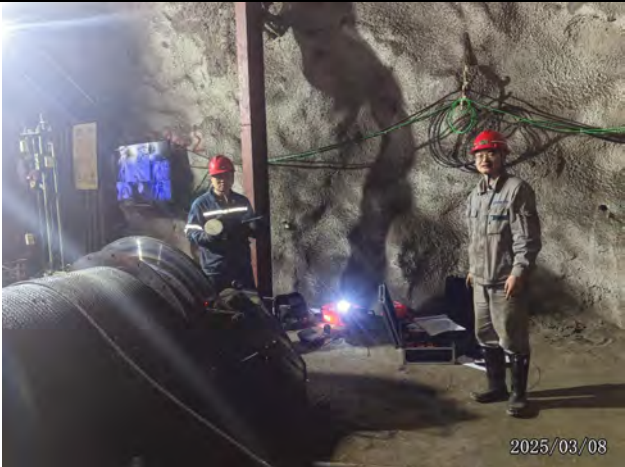
| 79 | GX-B1305/21-2-25001 | 2025/4/11 | 综合判定：合格。 | A photograph showing two workers in a tunnel. One worker is wearing a blue uniform and a red helmet, holding a clipboard. The other worker is wearing a grey uniform and a red helmet, standing next to a large piece of equipment. The tunnel walls are rough and there are some cables hanging from the ceiling. A date stamp '2025/03/08' is visible in the bottom right corner of the photo. |

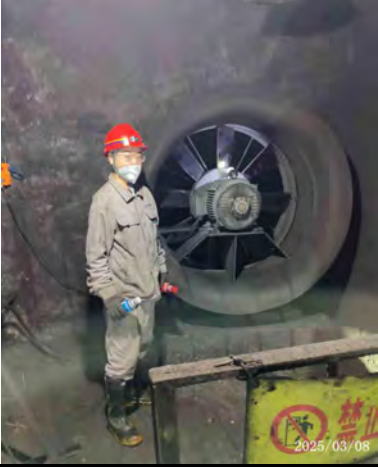
| 80 | GX-B1428/21-2-25059 | 2025/4/10 | 无缺陷痕迹显示。 | A photograph showing a worker in a grey uniform and a red helmet, wearing a face mask, inspecting a large fan or turbine. The worker is holding a flashlight. The fan has a large circular frame with multiple blades. A date stamp '2025/03/08' is visible in the bottom right corner of the photo. |

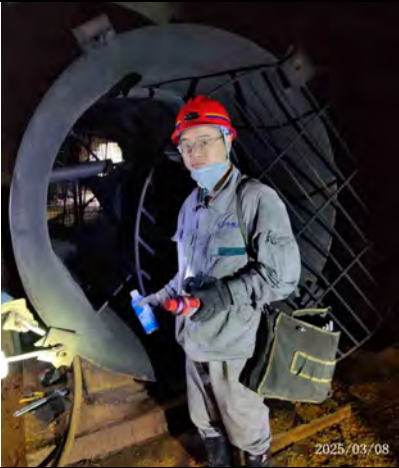
| 81 | GX-B1428/21-2-25060 | 2025/4/10 | 无缺陷迹痕显示。 | |

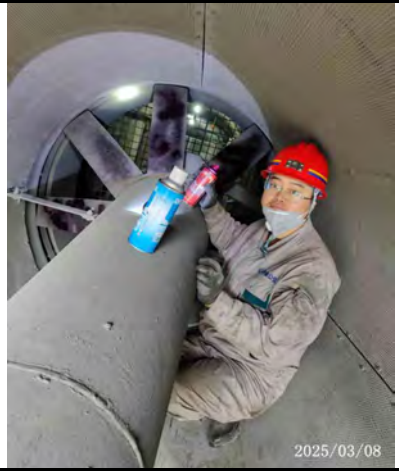
| 82 | GX-B1428/21-2-25061 | 2025/4/10 | 无缺陷迹痕显示。 | |

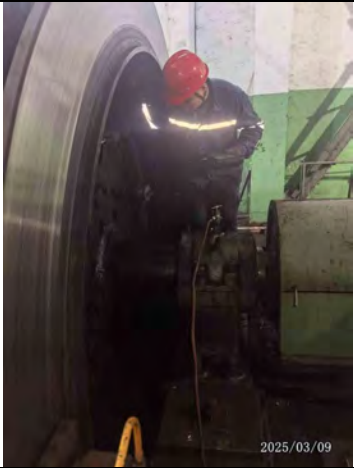
| 83 | GX-B1310/21-2-25062 | 2025/4/10 | 符合标准要求。 | |

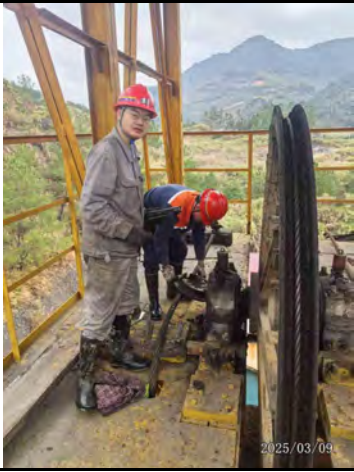
| 84 | GX-B1310/21-2-25063 | 2025/4/10 | 符合标准要求。 | |

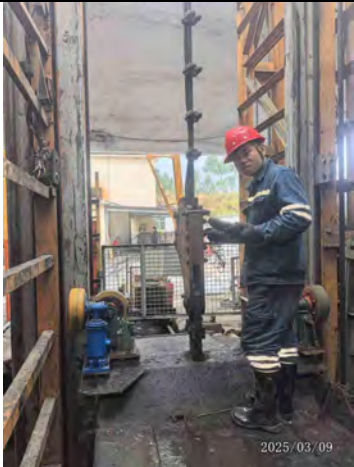
| 85 | GX-B1310/21-2-25064 | 2025/4/10 | 符合标准要求。 | <p>2025/03/09</p> |

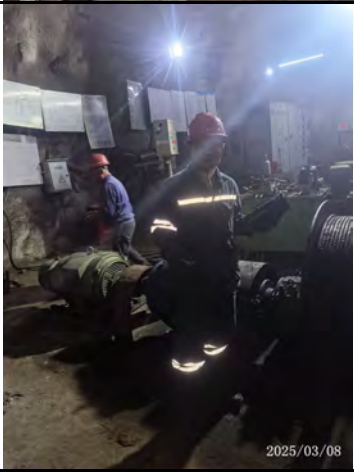
| 86 | GX-B1310/21-2-25065 | 2025/4/10 | 符合标准要求。 | <p>2025/03/08</p> |

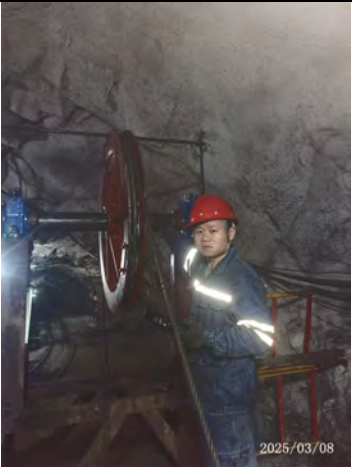
| 87 | GX-B1310/21-2-25066 | 2025/4/10 | 符合标准要求。 | |

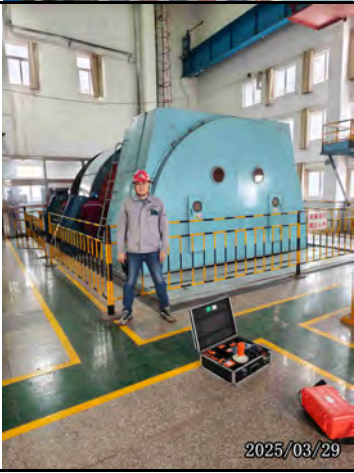
| 96 | GX-B1304/21-2-25005 | 2025. 4. 13 | 综合判定：合格。 | |

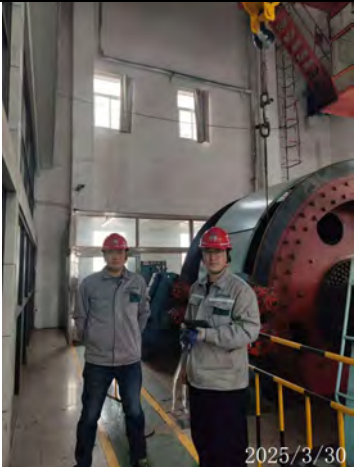
| 97 | GX-B1304/21-2-25006 | 2025. 4. 13 | 综合判定：合格。 | A photograph showing two workers in grey uniforms and red hard hats standing in a large industrial facility. They are positioned next to a large, dark-colored cylindrical machine component. The date '2025/3/30' is visible in the bottom right corner of the image. |

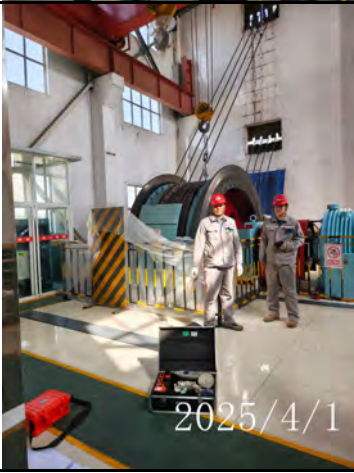
| 98 | GX-B1304/21-2-25007 | 2025. 4. 13 | 综合判定：合格。 | A photograph showing two workers in grey uniforms and red hard hats standing in a large industrial facility. They are positioned next to a large, dark-colored cylindrical machine component. The date '2025/4/1' is visible in the bottom right corner of the image. |

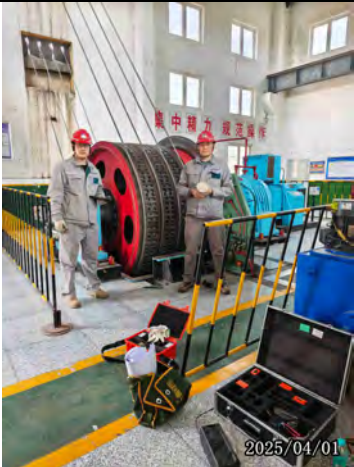
| 99 | GX-B1304/21-2-25008 | 2025. 4. 13 | 综合判定：合格。 | |

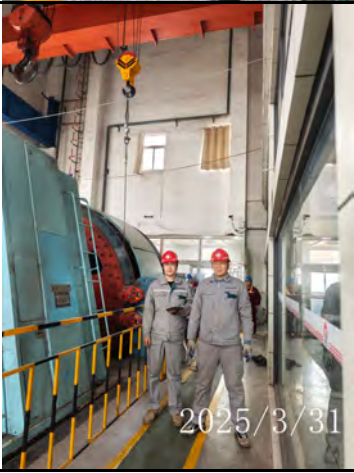
| 100 | GX-B1304/21-2-25009 | 2025. 4. 13 | 综合判定：合格。 | |

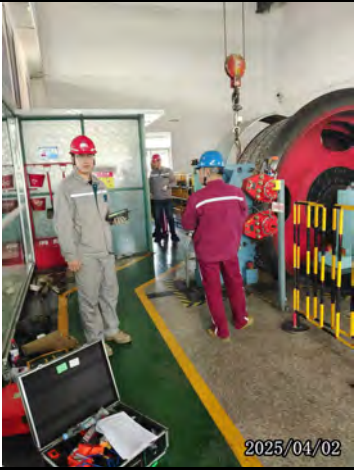
| 101 | GX-B1304/21-2-25010 | 2025. 4. 13 | 综合判定：合格。 | |
